STRENGTHENING OF KEYED LONGITUDINAL CONSTRUCTION
JOINTS IN RIGID PAVEMENTS

ARMY ENGINEER WATERWAYS EXPERIMENT STATION

AUGUST 1972

Report No. FAA-RD-72-106

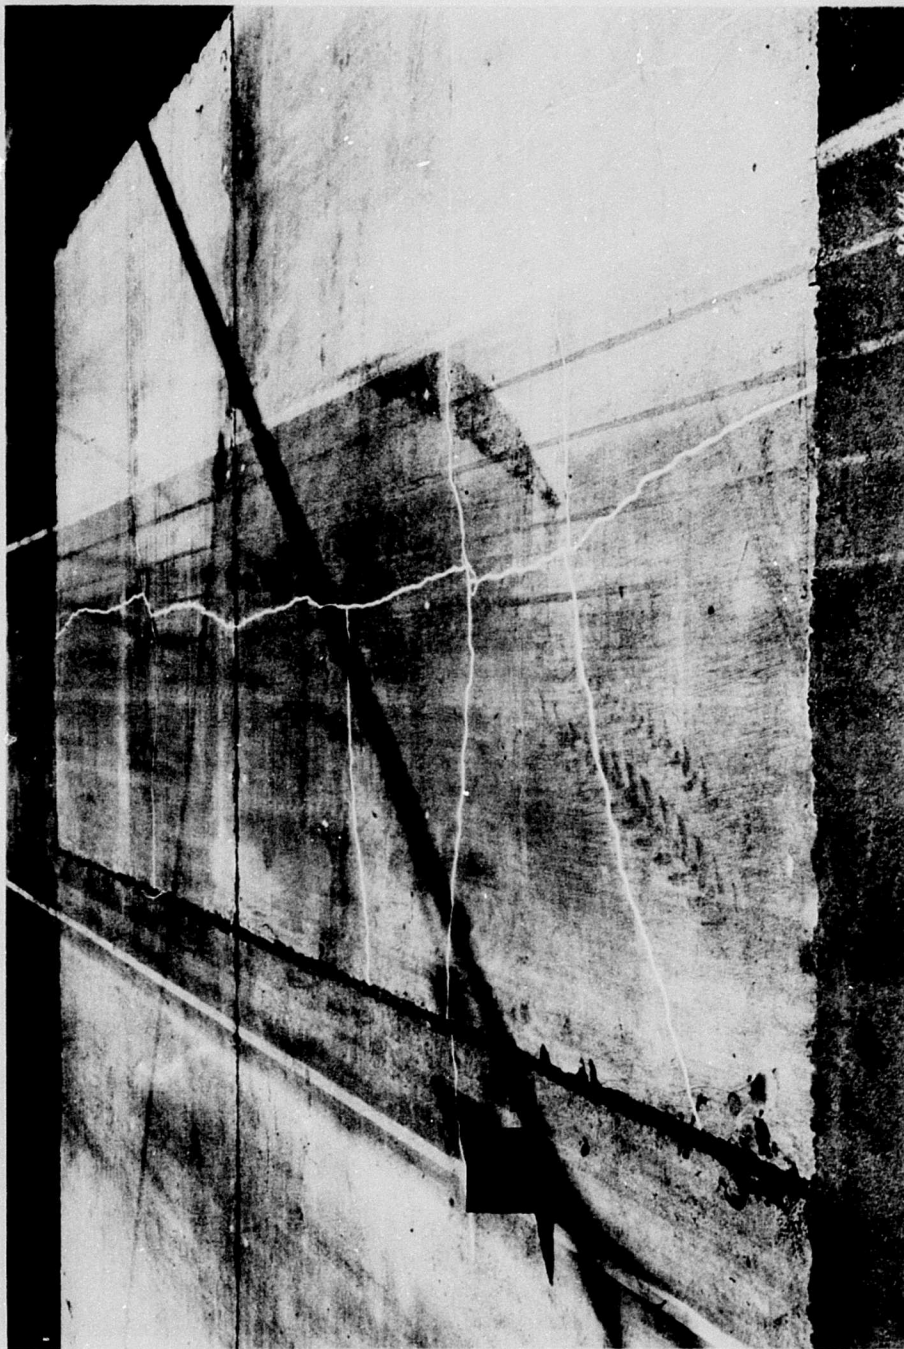
Figure 28. Item 1, 360-kip, 12-wheel-assembly lane after 144 coverages.

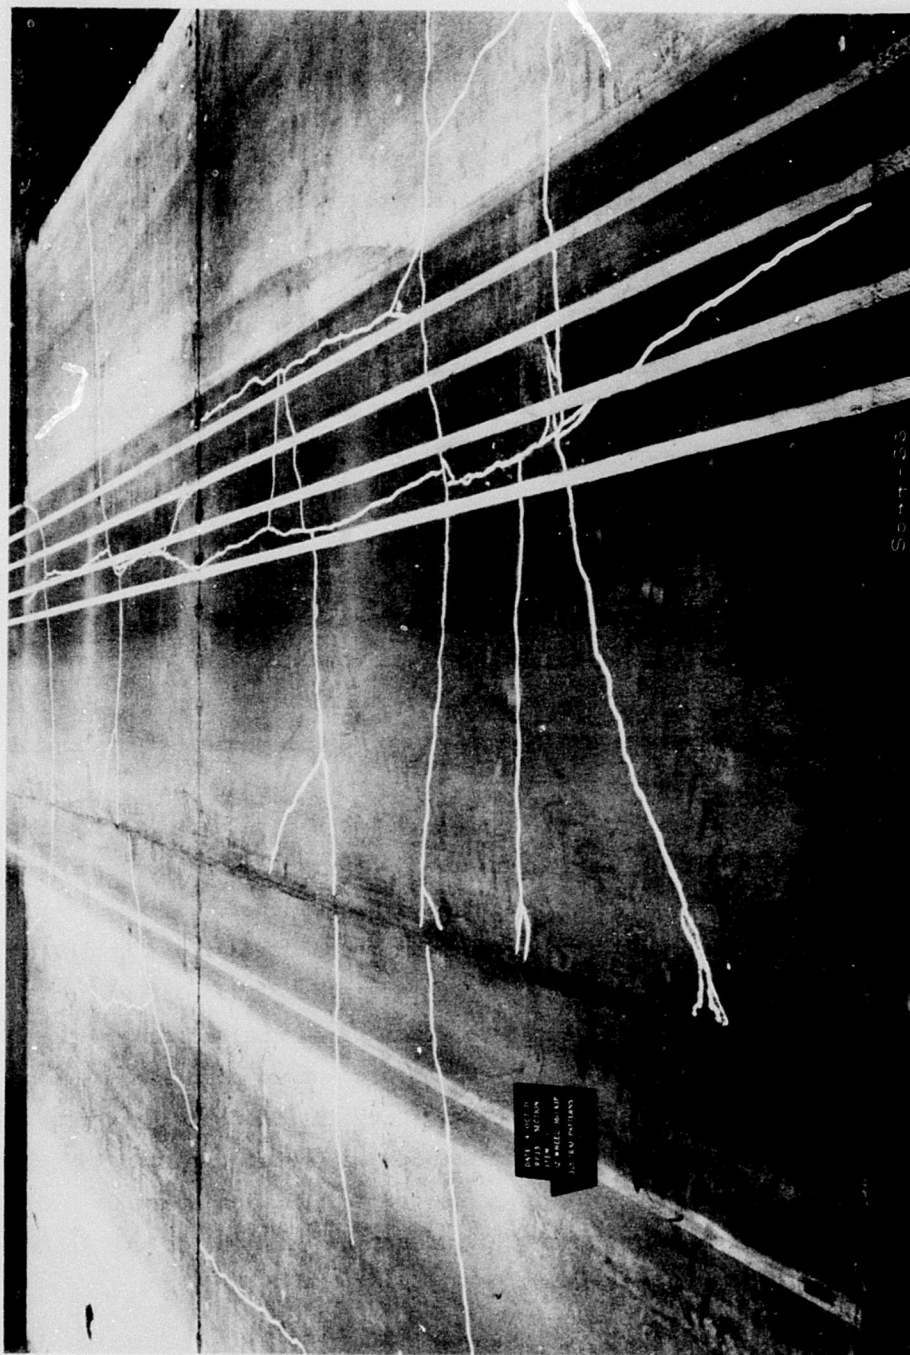
of the item. Additional surface cracking had developed in both of the north slabs and in the southwest slab after 504 coverages. Figure 29 depicts the crack pattern in this item after 504 coverages. Several of the cracks in the southwest slab were severely spalled and raveled. Traffic was stopped after 43 traffic patterns (688 coverages) due to the severe faulting of the keyed longitudinal construction joint, as well as the shattered-slab failures of both south slabs and the item was rated as failed. Figure 30 indicates faulting of $3/8$ to $1/2$ in. after 688 coverages at the construction joint between the southwest and northwest slabs. An overall view of the item after 688 coverages is shown in figure 31; the progression and extent of cracking due to test traffic is shown in figure 32. After traffic was discontinued, a portion of the southwest slab adjacent to the keyed construction joint was removed to confirm the joint failure. As can be seen in figure 33, the bottom half of the keyway of the keyed longitudinal construction joint was failed. The longitudinal construction joint containing the dowel bars on 12-in. centers in the eastern half of the item was in satisfactory condition at the end of traffic.

Figure 29. Item 1, 360-kip, 12-wheel-assembly lane after 504 coverages.

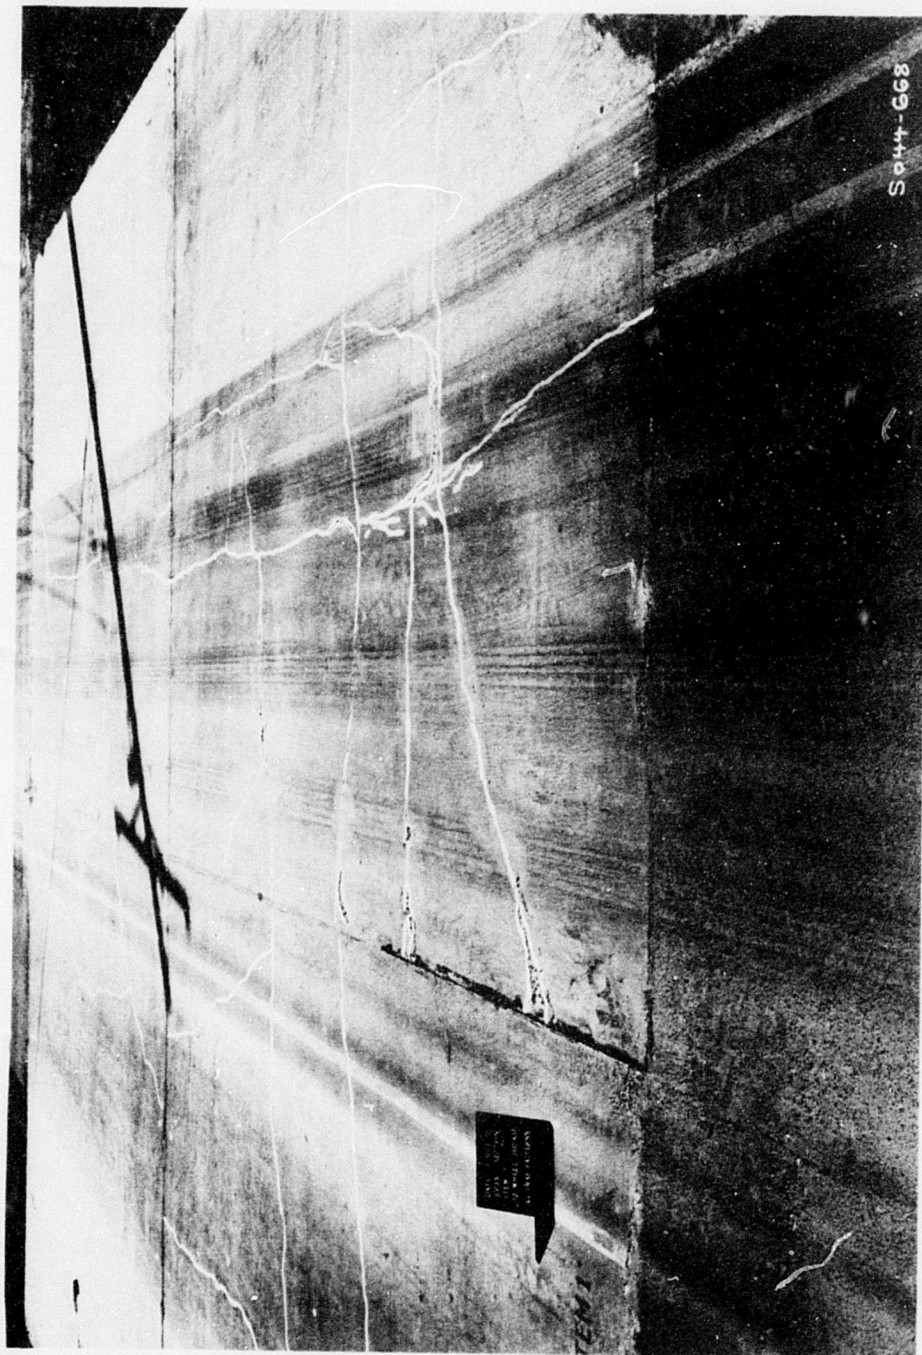
Figure 31. General view of item 1, 360-kip, 12-wheel-assembly lane after 688 coverages.

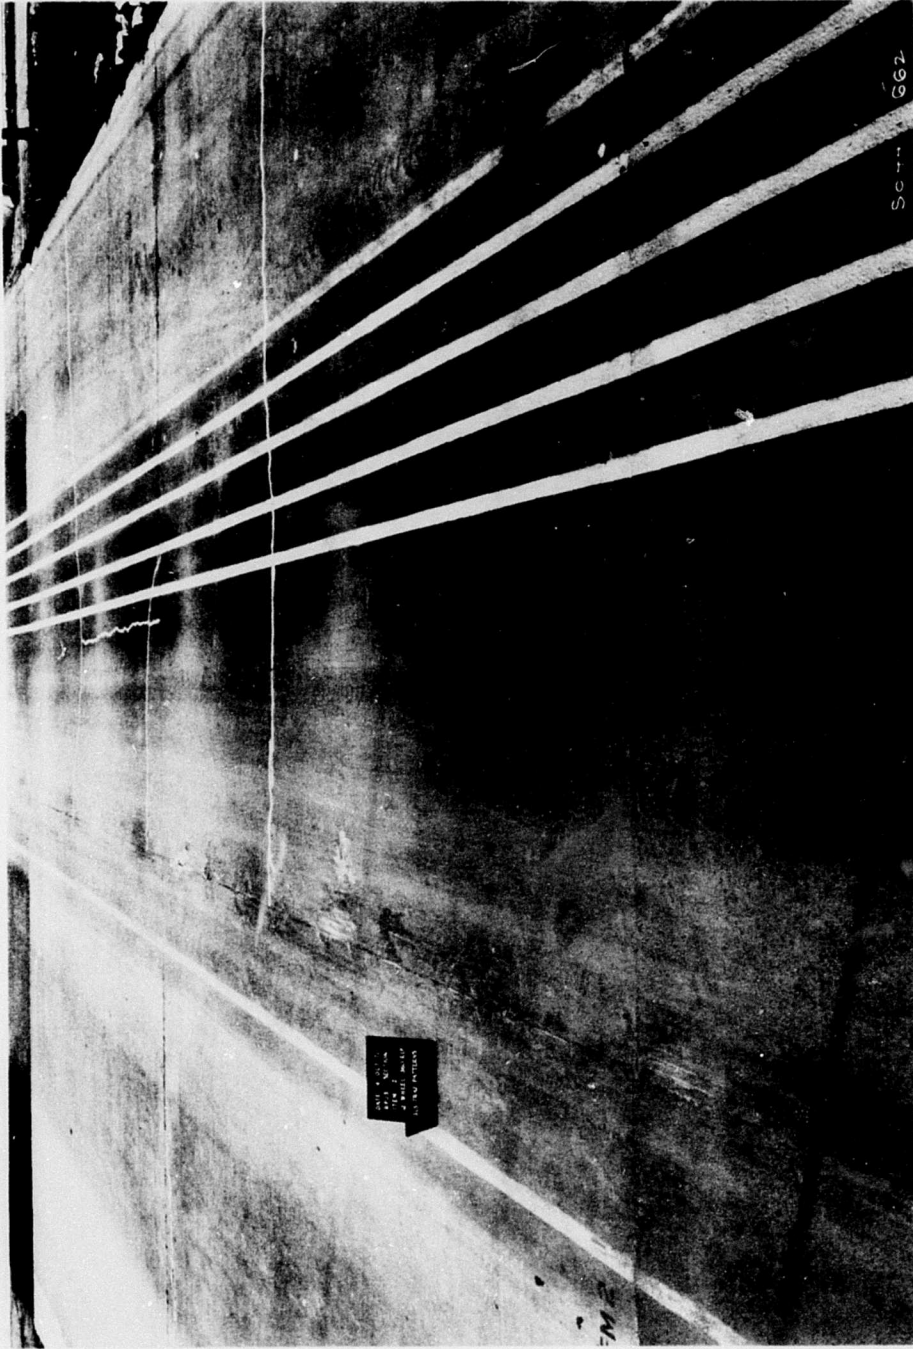
Figure 37. Item 2, 360-kip-assembly lane after 504 coverages.

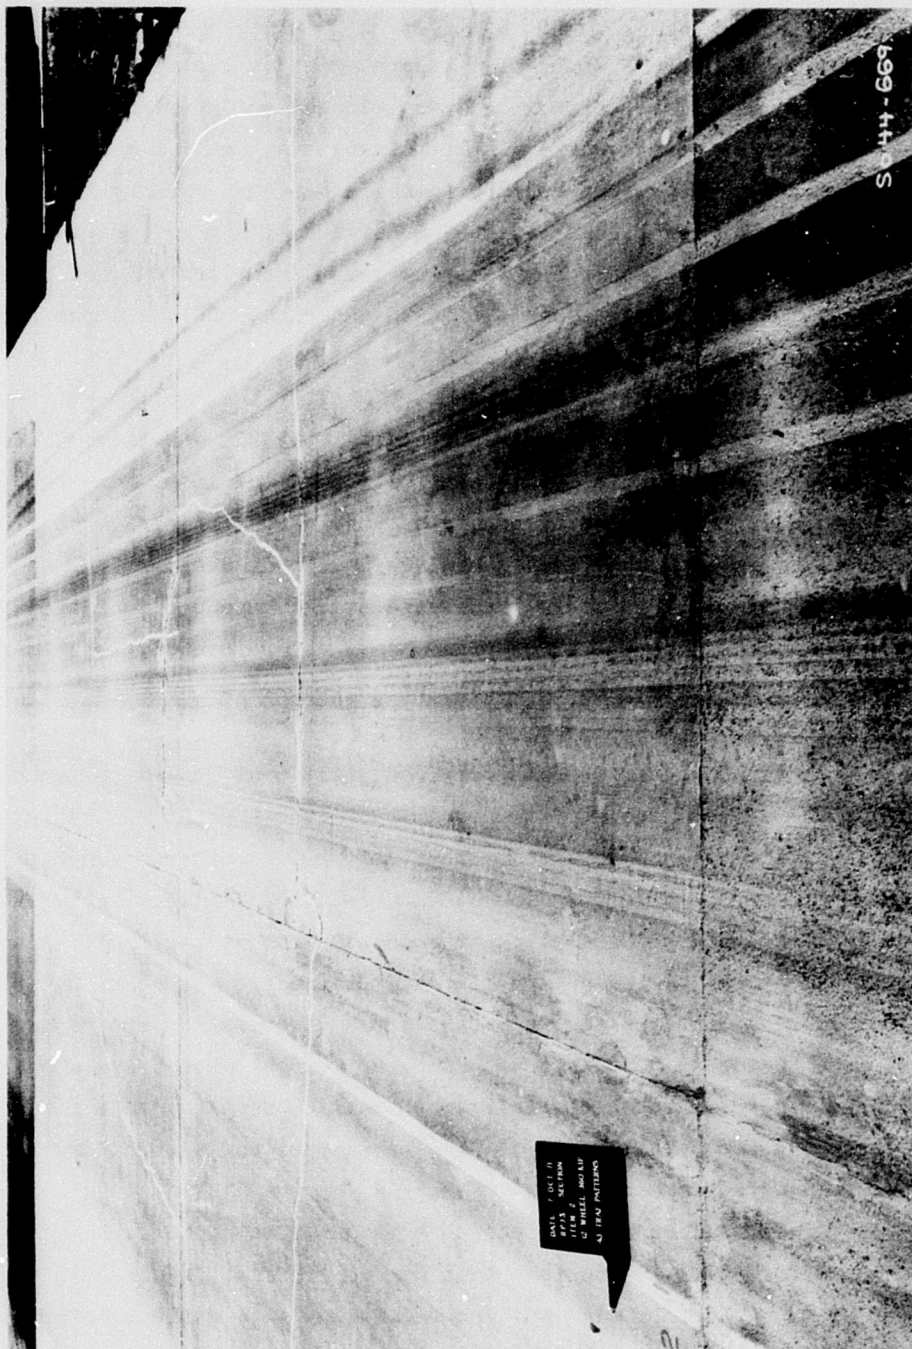
Figure 39. General view of item 2, 360-kip, 12-wheel-assembly lane after 688 coverages.

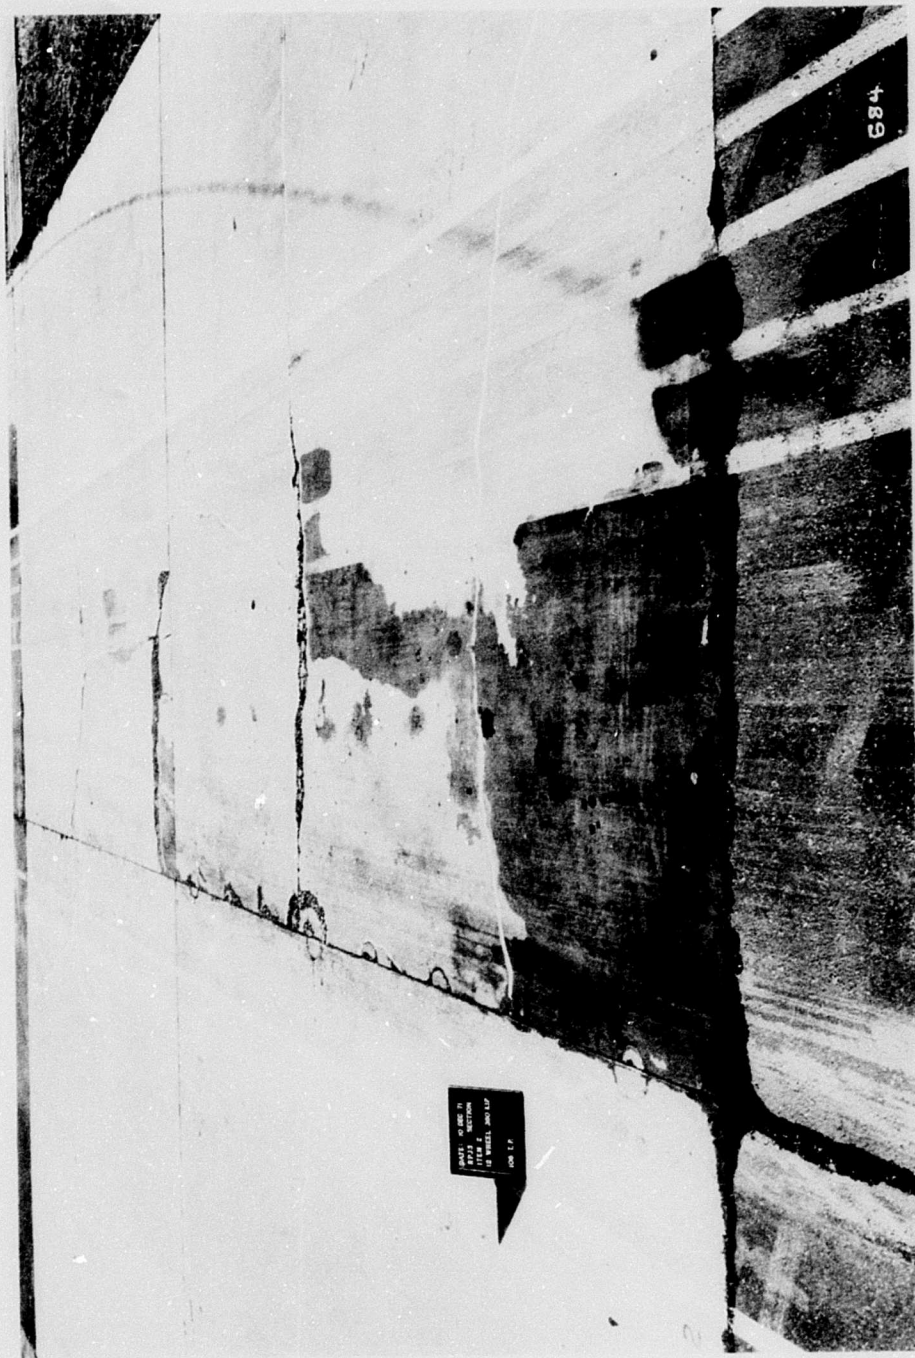
Although failure had occurred, test traffic was continued to determine the effectiveness of the other two methods of strengthening keyed joints employed in this test item. After 106 patterns (1696 coverages), traffic was discontinued on the entire item because of the severe spalling and raveling along cracks. Other than the spalling and raveling along cracks, the only additional distress observed on the pavement surface occurring between 816 and 1696 coverages were corner cracks located in the northeast and southeast slabs. These are shown in figures 41 and 42. At the conclusion of traffic, sections of the keyed construction joint strengthened by both horizontal and slanted dowel bars were performing satisfactorily.

Figure 41. Item 2, 360-kip, 12-wheel-assembly lane after 1696 coverages.

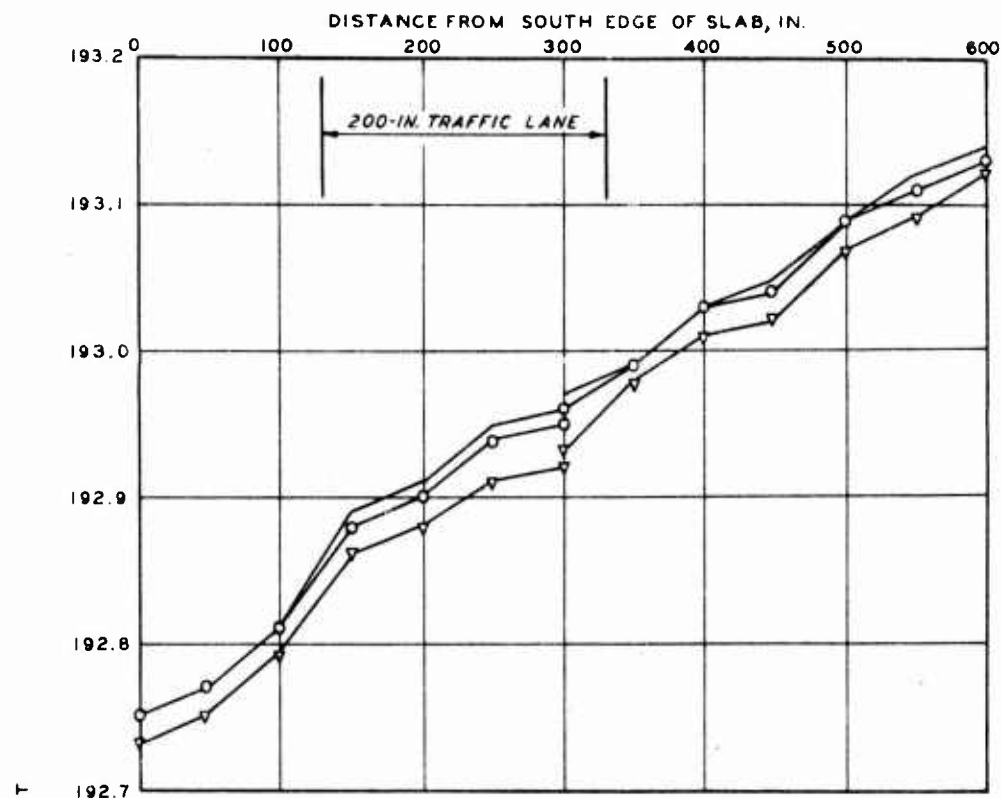
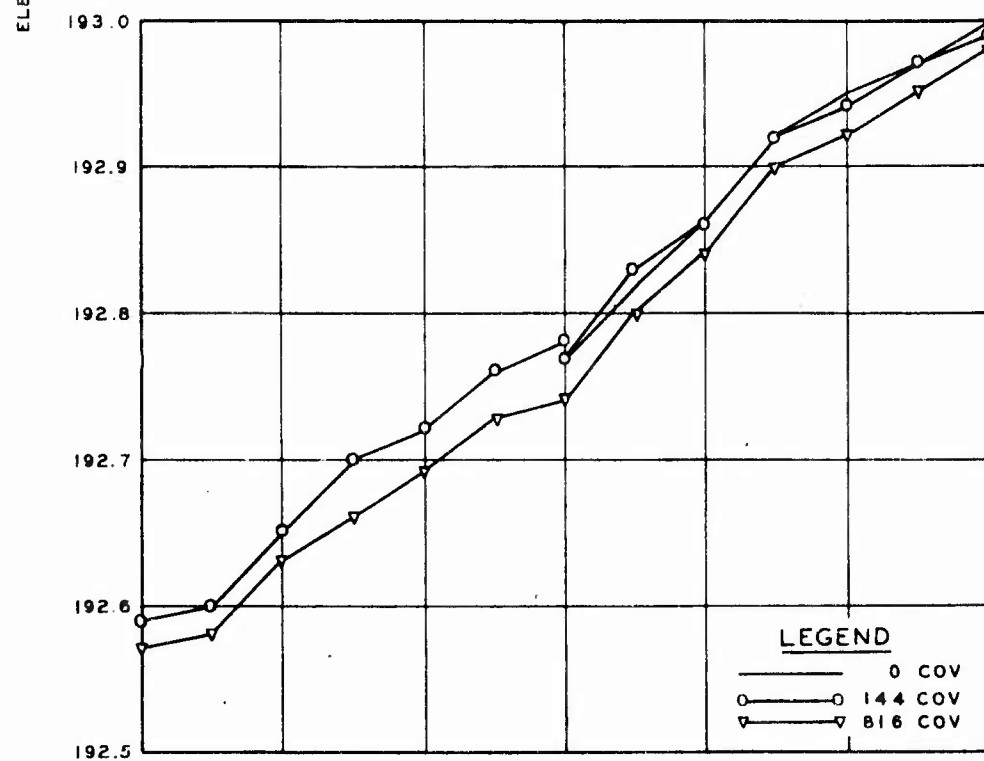
Figure 43. Typical cross sections of item 2, 360-kip, 12-wheel-assembly lane.

Typical cross sections at the center of each slab show the permanent deformation in the test lane due to traffic (figure 43). The average permanent deformation was about 0.24 in. with maximum deformation of 0.48 in.

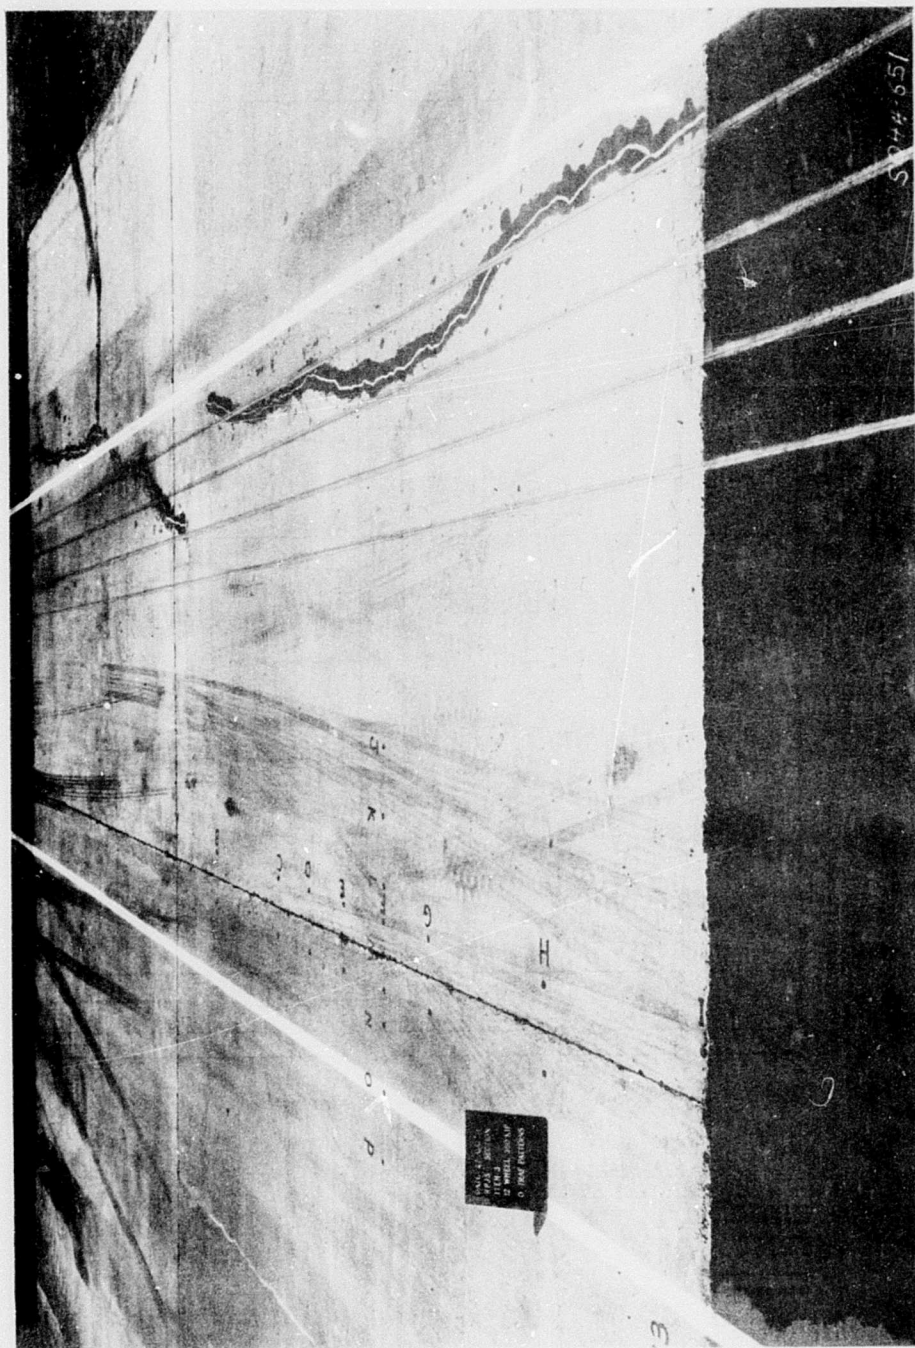
A general view of item 3 prior to test traffic is shown in figure 45. As can be seen in this photograph, several cracks developed during the curing of the slab. An epoxy cement was placed under pressure (10 psi) into the longitudinal cracks located in the southeast slab running from the south free edge of the slab to the longitudinal joint. Epoxy cement was first applied to the surface of the pavement and allowed to cure before the epoxy cement was forced under 10-psi pressure into the cracks. There was also a transverse crack between the southwest and southeast slabs parallel to the weakened-plane construction joint. However, since this crack developed prior to the construction of the weakened-plane joint, it was decided to consider the crack as the joint between the two slabs.

Figure 45. Item 3, 360-kip, 12-wheel-assembly lane prior to traffic.

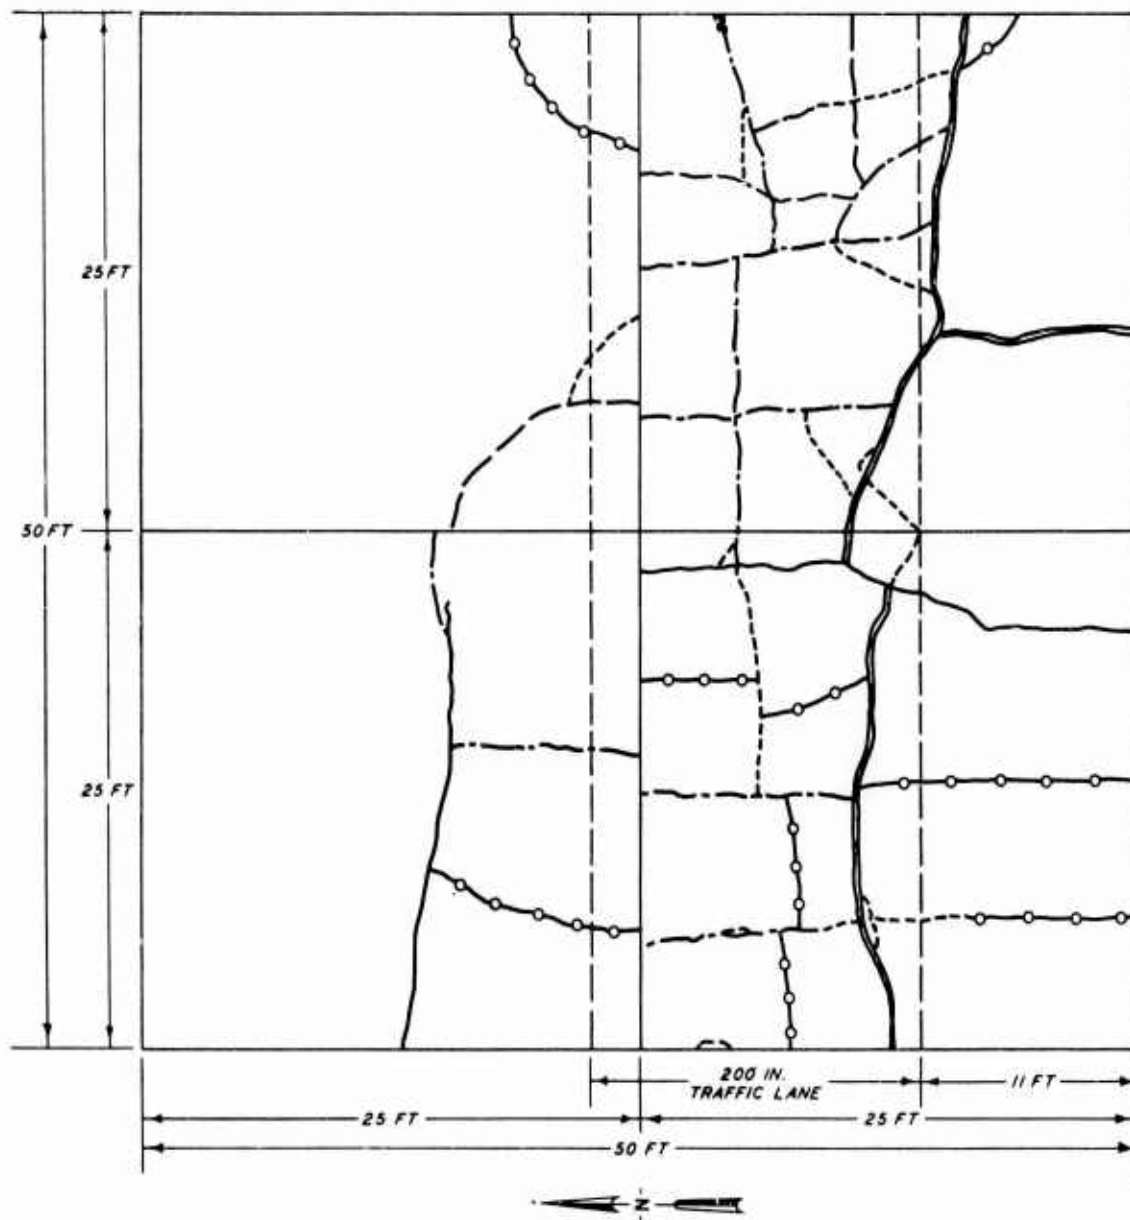
Prior to the application of continuous test traffic, 22 coverages of traffic were accumulated while recording instrumentation data. During this time two transverse cracks developed in the southeast and southwest slabs, and a longitudinal and a transverse crack appeared in the northwest slab. The length and location of these cracks can be determined from the data plotted in figure 46.

Figure 46. Crack development in item 3 under 360-kip, 12-wheel-assembly traffic.

the doweled longitudinal construction joint. After 96 coverages, the crack had progressed approximately 14 ft across the slab to a longitudinal crack that had been epoxied prior to traffic. After 9 patterns of traffic (144 coverages), the surfaces of the southwest and southeast slabs had subdivided into 4 and 8 pieces, respectively, as indicated in figures 46 and 47. Although the southeast slab met the shattered-slab failure criterion at this time, traffic was continued because the longitudinal construction joint was performing satisfactory.

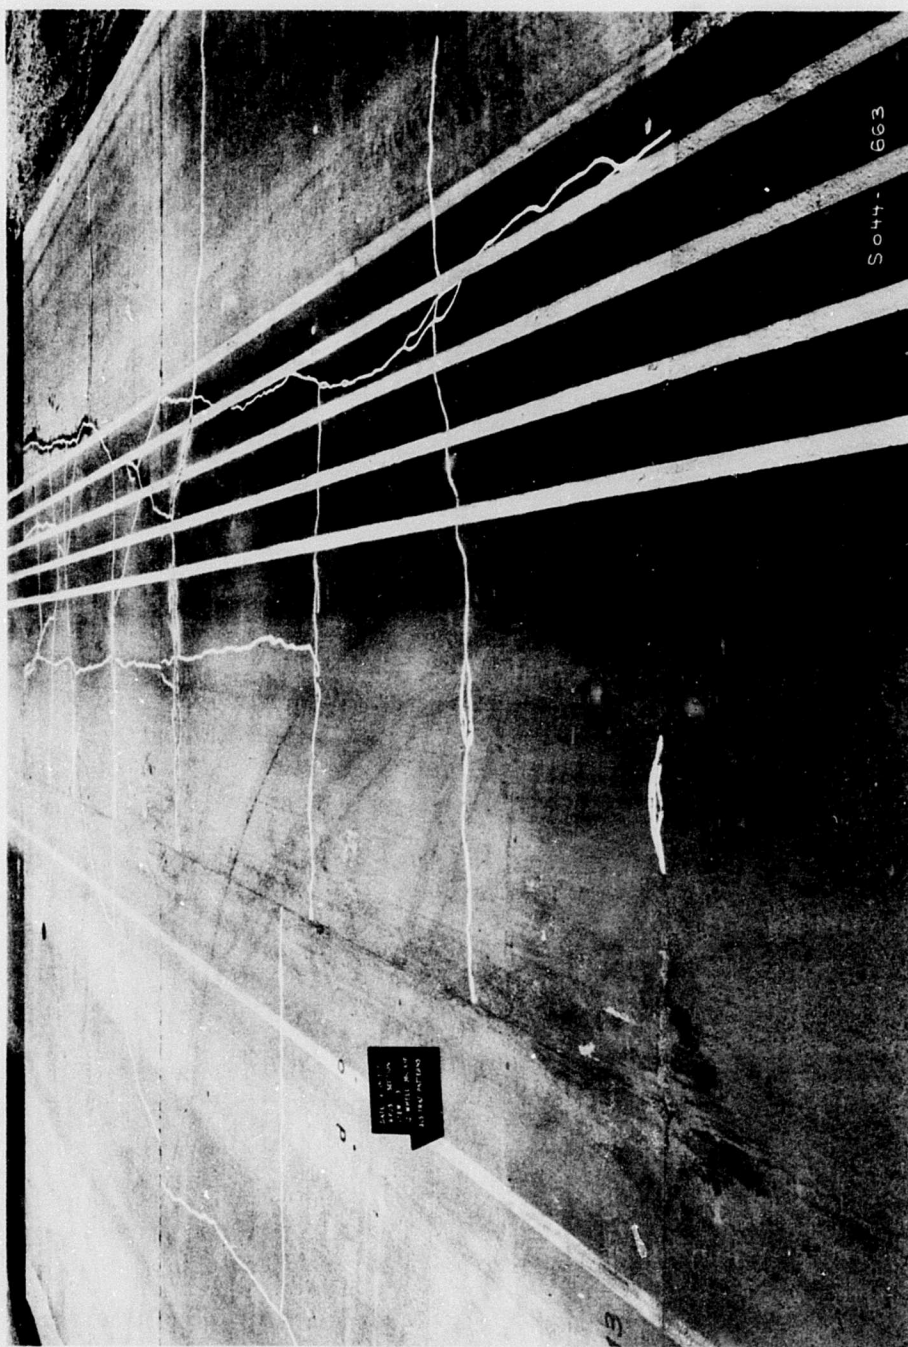
As traffic was continued, several transverse and longitudinal cracks developed in the southeast and southwest slabs and the existing cracks, mainly transverse, were working. After 31.5 patterns (504 coverages), the east slab in the south lane was broken into 19 pieces and the west slab in the lane was subdivided into 5 pieces. The general condition of this item after 31.5 patterns is shown in figure 48. Figure 49 depicts the extent of flaking and spalling that had developed at the crack between the two south slabs at the 31.5 traffic pattern level. Only slight working of the other cracks was noticed at this time. During the next 12.5 patterns of traffic, two longitudinal and four transverse cracks developed in the southwest slab; 11-ft-long transverse crack running from the longitudinal construction joint in an existing longitudinal crack in the northwest slab was detected; and a corner break occurred in the northeast slab. An overall view of item 3 after 43 patterns (688 coverages) is shown in figure 50. As can be seen, severe spalling had occurred in several of the transverse cracks located in the two south slabs. A close-up of a typical spalled area after loose material was removed is shown in figure 51. Due to the severe spalling of several of the transverse cracks and the number of pieces into which the two south slabs had subdivided, test traffic was stopped after 43 patterns of traffic (688 coverages). At the end of traffic, both slabs in the south lane were subdivided into more pieces than that constituting shattered-slab failure. The progression of cracking with traffic is shown in figure 46. The doweled longitudinal construction joint performed very well during test traffic; it was rated as in satisfactory condition at the end of traffic.

Figure 48. Item 3, 360-kip, 12-wheel-assembly lane after 504 coverages.

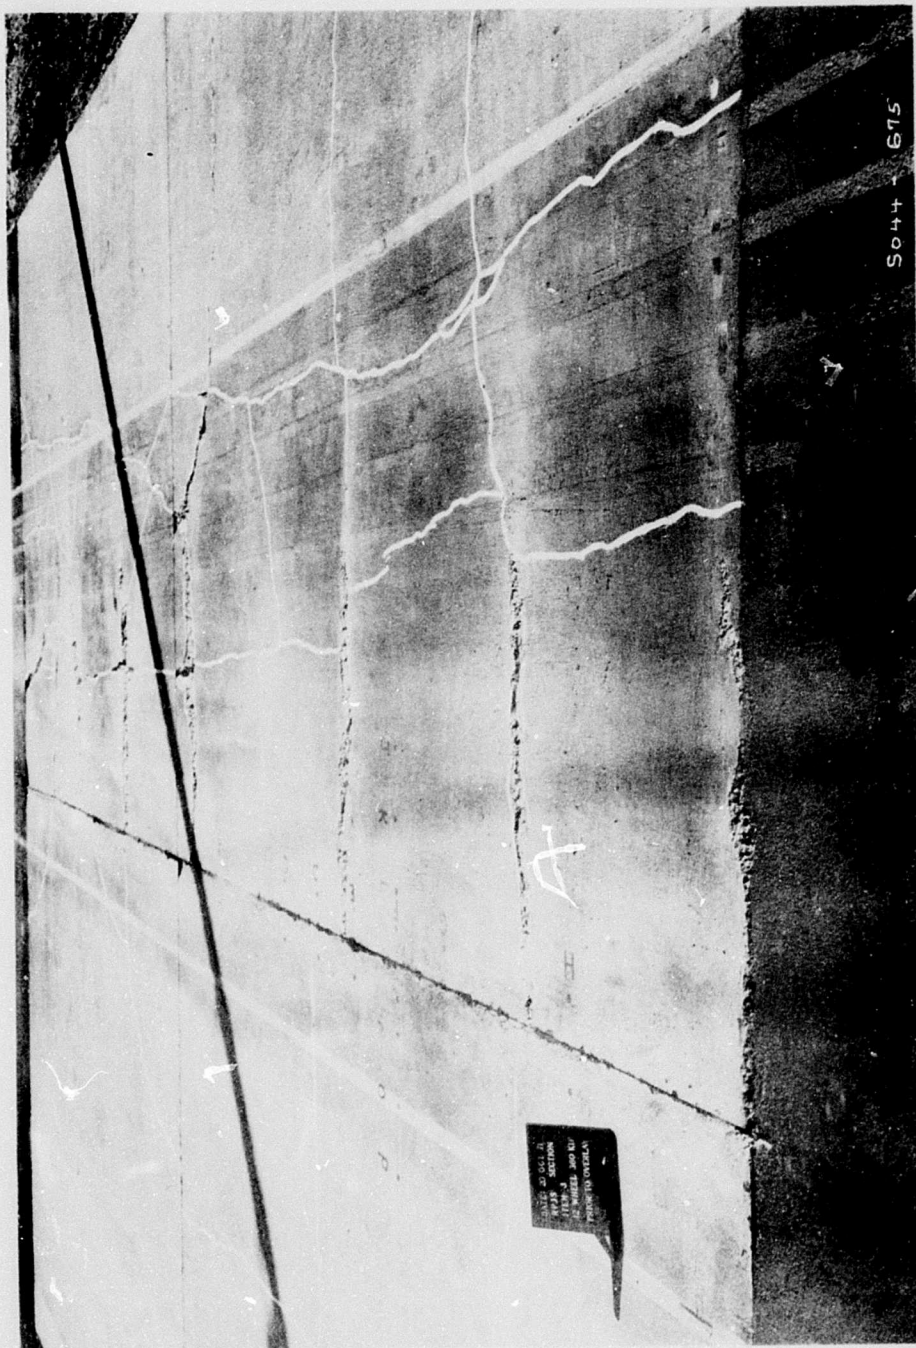
Figure 50. Item 3, 360-kip, 12-wheel-assembly lane after 688 coverages.

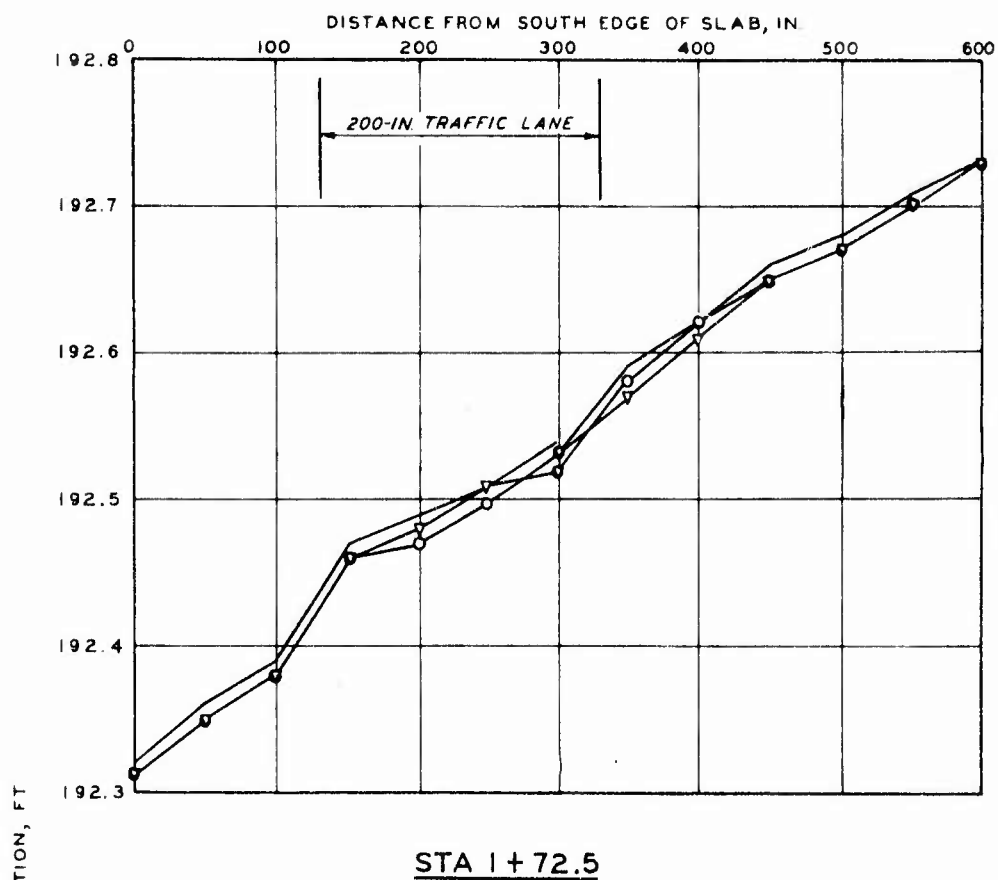
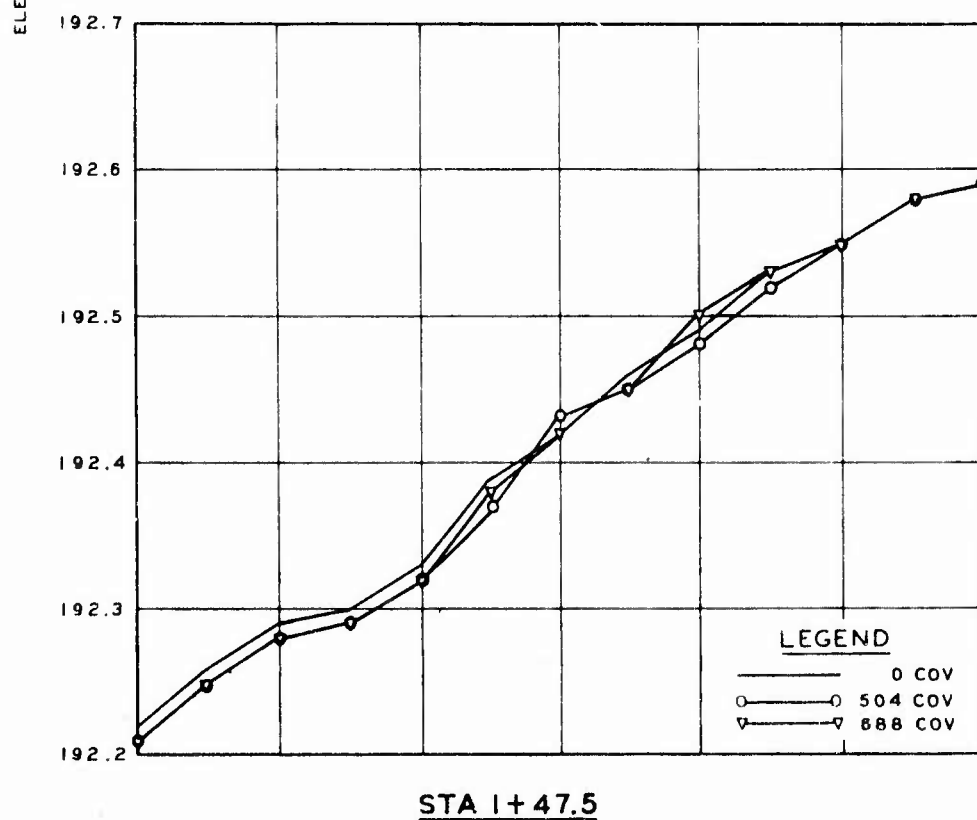
The typical cross-section plot of item 3 shown in figure 52 indicate that the average permanent deformation after 688 coverages (prior to overlaying) was about 0.18 in., and the maximum deformation measured was 0.24 in.

Figure 52. Typical cross sections of item 3, 360-kip, 12-wheel-assembly lane.

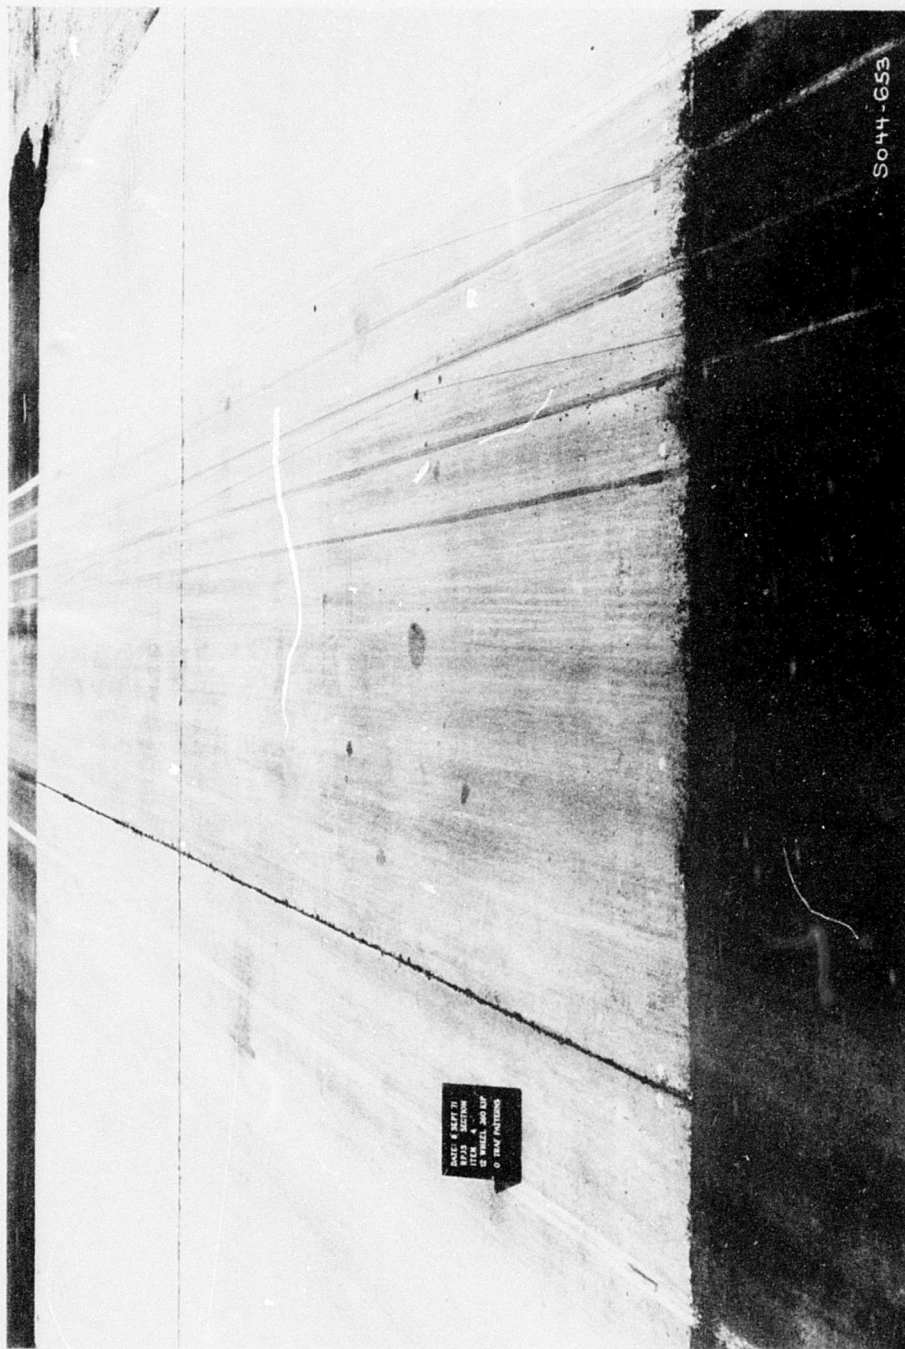
There were no defects in item 4 prior to traffic, as shown in figure 54. Pumping at the joints between the transition areas and the east and west ends of the item was noted after only 1.5 traffic patterns (24 coverages) and became progressively worse as traffic continued. The first crack was observed during the 54th traffic pattern (864 coverages). This was a half-moon-shaped crack located at the west end of the item. The pumping is believed to have contributed to this break and to the large corner breaks detected in the southeast and northeast slabs after 83 patterns of traffic (1328 coverages). These two corner breaks were the only additional distress observed at the 1328-coverage level. A general view of this item showing the crack pattern after 83 traffic patterns is shown in figure 55. After 146 traffic patterns (2336 coverages), the western edge of the half-moon-shaped crack in the southwest slab was approximately 1/2-in. below its original elevation due to the pumping of the subgrade material beneath the slab, and a 4-ft longitudinal crack was observed running from the west edge of the slab to the existing half-moon-shaped crack. These moon-shaped cracks at each end of the test item were

Figure 54. Item 4, 360-kip, 12-wheel-assembly lane prior to traffic.

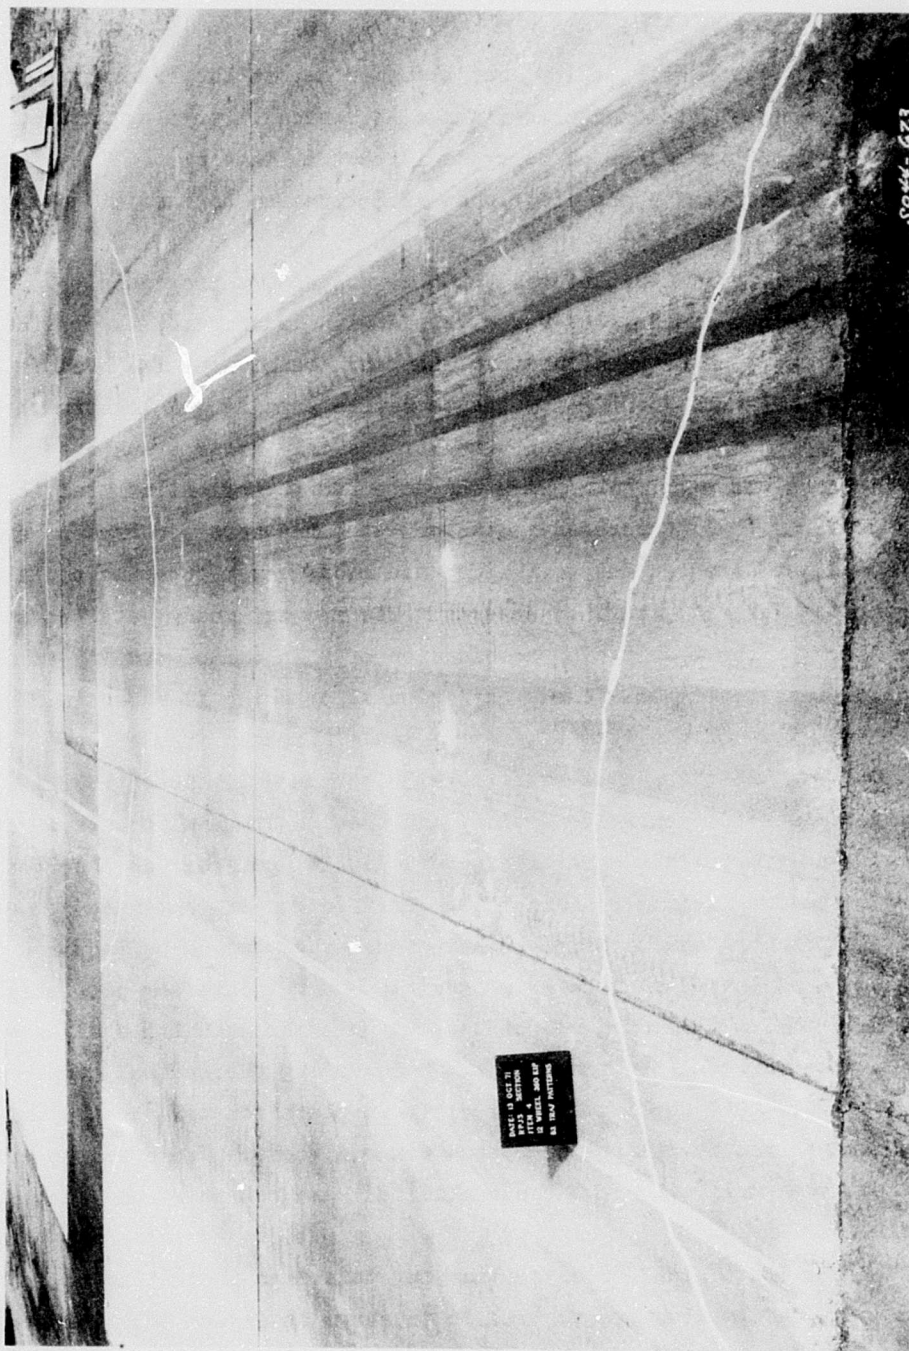
- Figure 55. Item 4, 360-kip, 12-wheel-assembly lane after 1328 coverages.

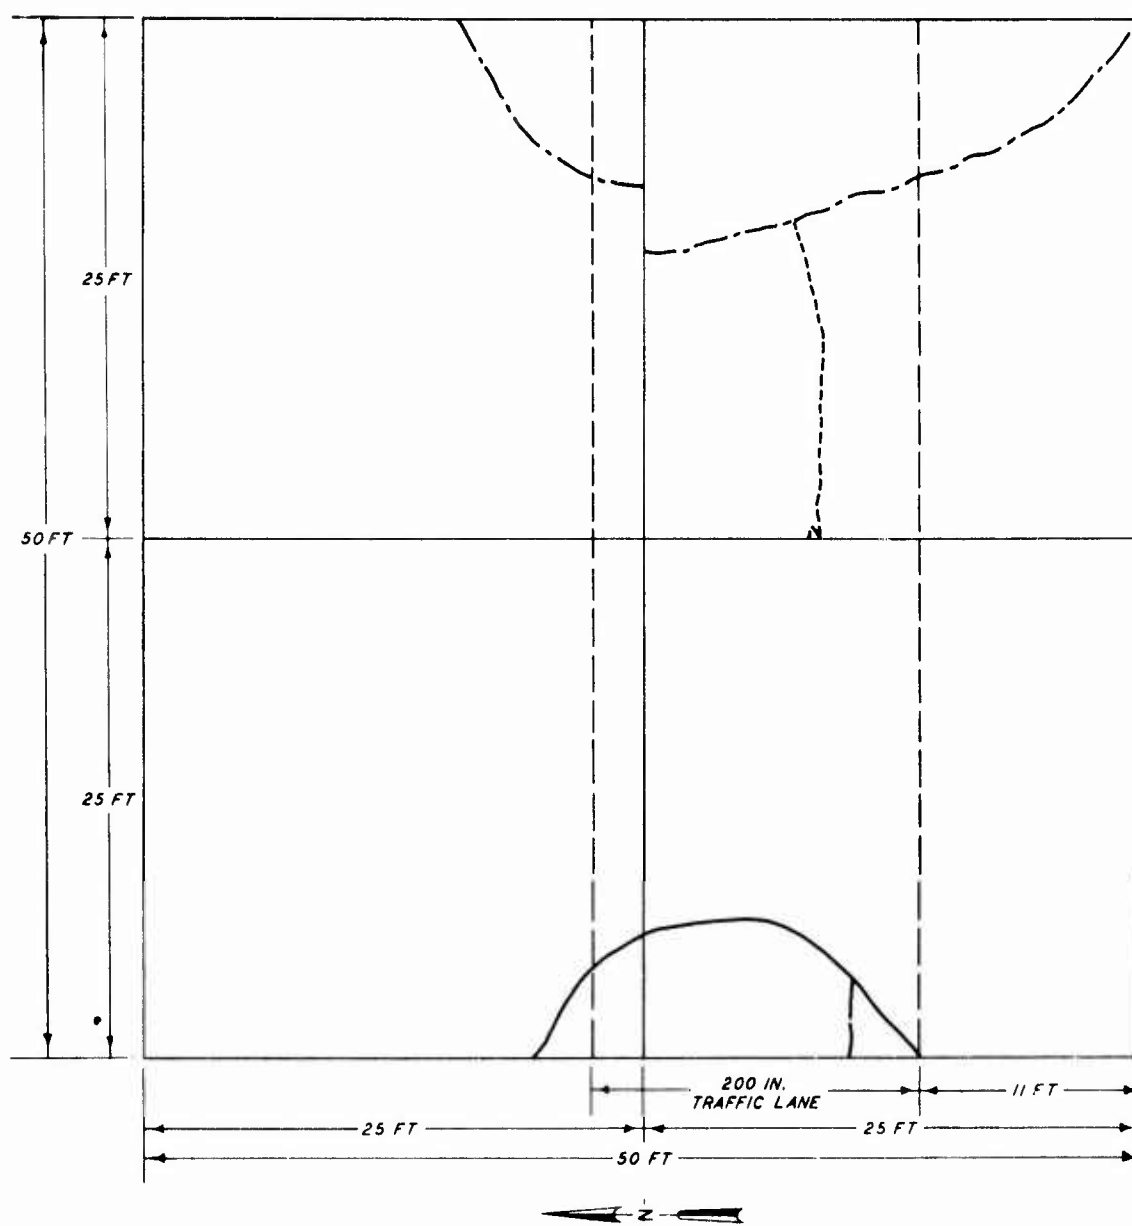
After 200 patterns (3200 coverages), approximately 6 ft of the western end of the item was overlaid with landing mat to provide a smooth transition between the test item and transition area because the test slab had sunk about 2 in. due to severe pumping. A longitudinal crack located in the southeast slab was the only other crack observed during test traffic. This crack was detected at the end of traffic, 396 patterns (6336 coverages); however, it could have occurred prior to this and not detected due to the mud and muddy water covering the slab during the last 197 traffic patterns. The mud and muddy water covering the slab was the result of a combination of rain and of pumping at both ends of this test item. The progression of cracking is shown in figure 56; a general view of the item after traffic is shown in figure 57.

Figure 56. Crack development in item 4 under 360-kip, 12-wheel-assembly traffic.
